# Transection of the Right Subclavian Artery by a Right Neck Central Venous Line, Resulting in Hemothorax and Need for Stenting by Interventional Radiology

Ping-An Chen-Carrington, K. Gage Parr\*, Anita Vincent and Raymond Pla

Department of Anesthesiology and CCM, The George Washington University Hospital, USA

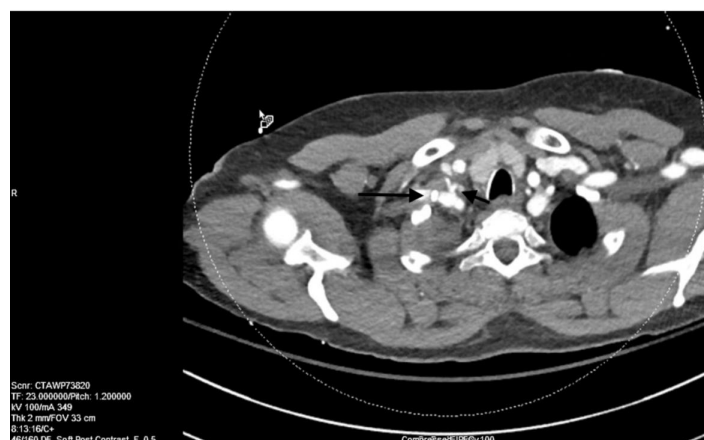
On post-operative day (POD) one, thoracic surgery was consulted and recommended computed tomography (CT) of the chest with contrast to determine the course of the CVL and source of bleeding. As the patient was stable, they also recommended interventional radiology (IR) intervention, if possible, to stop the bleeding, prior to placement of a chest tube. The CT with contrast revealed that the CVC possibly transfixied the right SCA, resulting in the right haemothorax. (Figure 1) As no definitive diagnosis could be made based on the CT scan, angiography was recommended.

**Figure 1.** CT Angiogram showing catheter (long arrow) passing through SCA. Thyro-cervical trunk is also marked (short arrow)

On POD1, the patient was taken to the IR suite and angiography was performed. This study showed that the catheter transfixated the right SCA adjacent to the thyro-cervical trunk. The catheter was removed, a right SCA stent was placed, and the thyro-cervical trunk was embolized to prevent endoleak due to retrograde thyro-cervical trunk blood flow. A right-sided chest tube was then placed, resulting in 550ml of bloody output. The patient tolerated the procedure well.
